No. CF-80-06

AIRWORTHINESS DIRECTIVE

CF-80-06 DE HAVILLAND

Main Landing Gear Leg - Precautionary Inspection and ReProtection - Modification Number 6/1660.

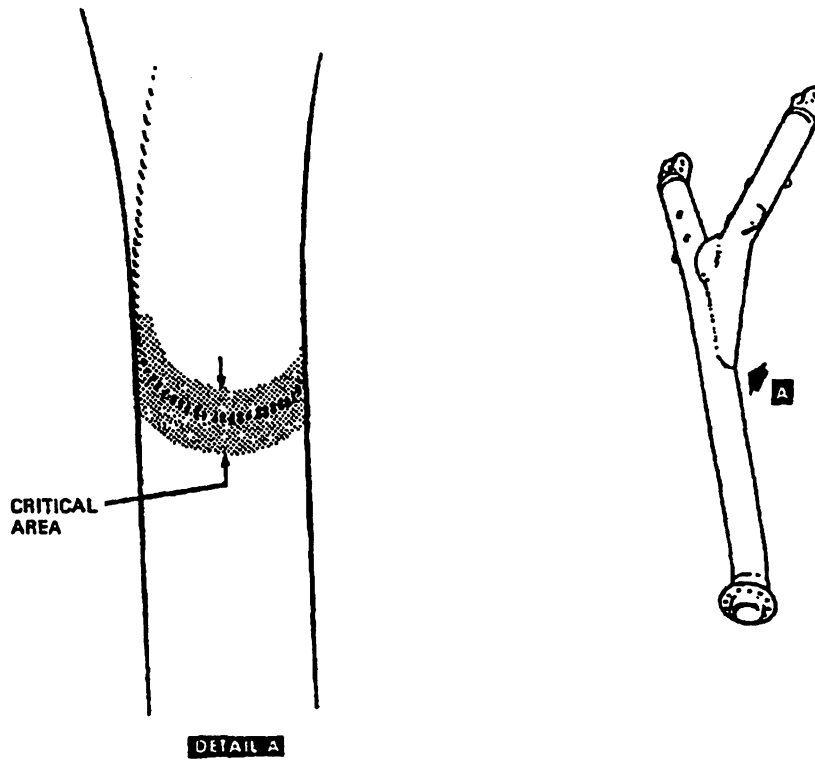
**LOWER Y WELD JOINT INSPECTION AREA
FIGURE 1**

Cracks initiating at corrosion pockets in the main landing gear Y-joint weld have been found.

Several failures of a leg assembly have been reported on aircraft operating in coastal areas. Investigation revealed the failure originated from cracks in the weld at the Y-joint emanating from a pocket of internal corrosion. The reissue of this service bulletin is to ensure that the main gear leg Check D will be correctly carried out.

In lieu of the visual external inspections required by paragraph (a) of Schedule No. 1 or Schedule No. 2, refer to the Accomplishment Instructions and Figure 1 of the referenced Service Bulletin, remove the external finish from the Inspection Area and inspect using a dye penetrant method. If no cracks are observed, reprotect the stripped area, and proceed in accordance with paragraph (b) of the appropriate Schedule. If cracks are found, proceed in accordance with Schedule No. 1 paragraph (e), (f), and (g) as appropriate.

- (a) Visually inspect external surface for cracking and any distortions to surface finish such as peeling, blistering etc.
- (b) If no irregularities are observed, operation may continue with a repeat of inspection as noted in Schedule Number 1(a) above, every 600 flight hours or 3 months, whichever occurs first until a Check D inspection is accomplished.
- (c) If irregularities are suspected, the external finish of the leg should be locally removed and the critical area subject to a dye penetrant crack detection.

- (d) If no cracks are found, reprotect stripped area and carry out repeat inspections as per Schedule Number 1(b).
- (e) If cracks are found, the area must be radiographed to determine exact extent of crack.

- (f) If cracking is confined to the weld or in the junction between the weld and parent metal, does not extend into the parent metal and does not exceed 3 inches in length, the leg should be repaired within 1200 flight hours or 6 months whichever occurs first. Prior to accomplishment of repair, crack must be checked for propagation beyond limits of Schedule Number 1(g) below using dye penetrant every 100 flight hours or 2 weeks, whichever occurs first.

- (g) If crack exceeds 3 inches in length or exists in parent metal, the leg assembly must be repaired or replaced before next flight. With concurrence of the relevant regulatory authority, a ferry flight to repair facility is considered acceptable.

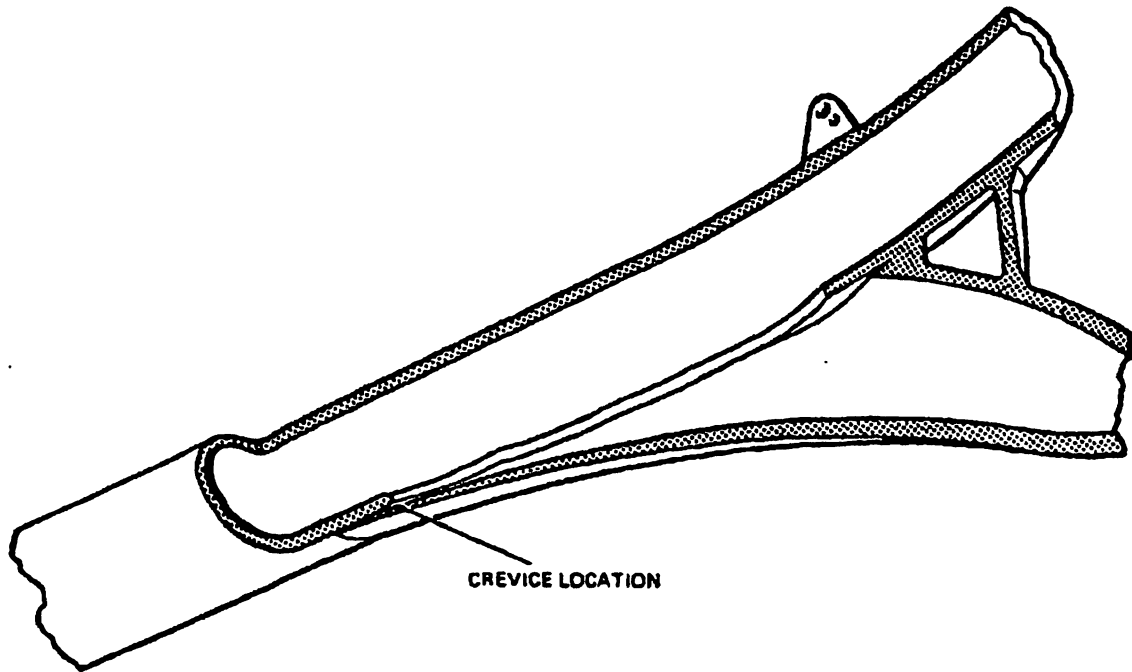
**CREVICE LOCATION - LOWER Y WELD JOINT
FIGURE 2**

- (a) Visually inspect the external surface as per Schedule 1(a) and visually inspect the inside of the leg assembly around the crevice location at the Y-joint (see Figure 2) for integrity of the internal finish coat and the presence of corrosion. Refer to Overhaul Manual PSM 1-6-6 Chapter 32-10-11 revised December 15th, 1978.
- (b) If no irregularities are observed, the operation may continue with a repeat inspection as noted in Schedule 2(a) above, every 2400 flight hours or 1 year, whichever occurs first until a Check D inspection of the leg is accomplished.
- (c) If external surface irregularities or internal corrosion are present at the Y-joint, proceed as in Schedule Number 1(c) and subsequently as in Schedule Number 1(d) or 1(e) and then as in Schedule 1(f) or 1(g).
